Case Study:

The Music Mill Concert Venue

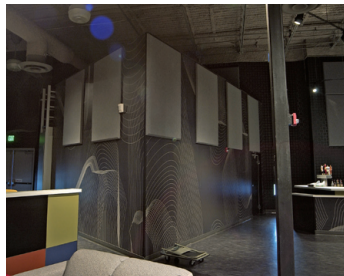
Figure 1: Irregular walls in the main venue

The acoustical environment of the main venue was the primary area of concern due to its irregular shape, reflective surfaces, 36' wide stage positioned in a corner, and the chosen audio system, an EV QRx monitoring rig and JBL line arrays and subwoofers.

Based on the off site analysis conducted as a part of Auralex's free room analysis service and the experienced issues discussed by the sound engineer, the problems included Reverberation Times (RTs) that were too long, harsh reflections off of the rear wall surfaces and inconsistent speech intelligibility throughout the main listening area. These issues required the strategic placement of absorption panels on various wall surfaces. While there were several types of products that would have been effective against the specific problems of this facility, Auralex Custom ProPanels were chosen because of their cost-effective nature, ability to be fit aesthetically into the design of the space, and general ease of installation.

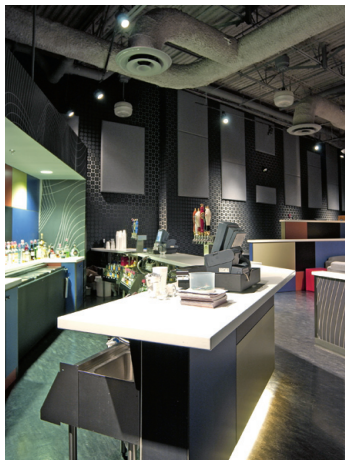
Figure 2: Modified panel layout on sidewall

While some on site modification was made to the original plan because of a previously unspecified insulated ceiling and wall obstructions that would not allow a continuous panel placement, the installation kept true to the original specification drawn up by Auralex Engineers.

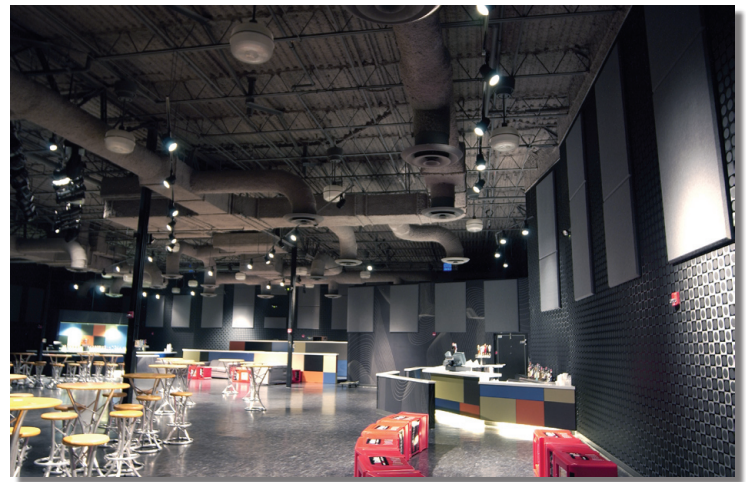
Auralex and Mid-America Sound coordinated the installation using trained local contractors and the full panel design was successfully implemented in two days.

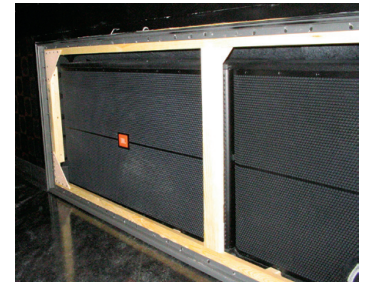
Figure 3: Framed subwoofer enclosure without the fabric installed

The four JBL dual 15" subwoofers were installed in a custom metal cavity directly under the main stage. In order to reduce the unwanted resonance of this cavity and provide a finished look to the stage front, additional Auralex products were needed. SonoFiber, an all-natural cotton-based absorber, was placed as a lining in the enclosure.

The front was then framed and finished using the ELiTE Custom Fabric System (CFS) and an acoustically transparent fabric.

Auralex certified ELiTE installers were contracted to implement the framing, ELiTE Retention Channel and fabric covering from Guilford of Maine.

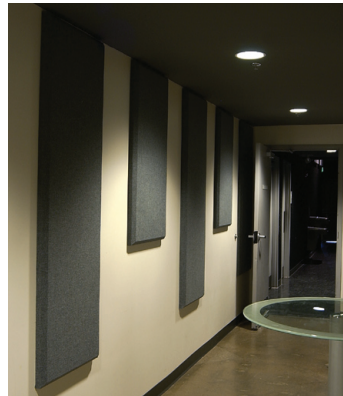
Figure 4: Auralex ProPanels in the backstage area

The final challenge presented by the staff of the Music Mill was the acoustic control of the backstage area. With reflective surfaces on all sides, the echo and resonance of the space from both speech and music created an unacceptable environment for performers, guests and personnel.

Once again, Auralex Custom ProPanels were suggested because of their superior broadband frequency absorption and aesthetic finished appearance.

Using the same fabric covering and similar panel design, the experienced problems were greatly diminished with only around 30% total coverage of wall surface area.
